Route 94  
Interchange

Eastbound I-70  
Transverse Grooving  
2725 Ft Long

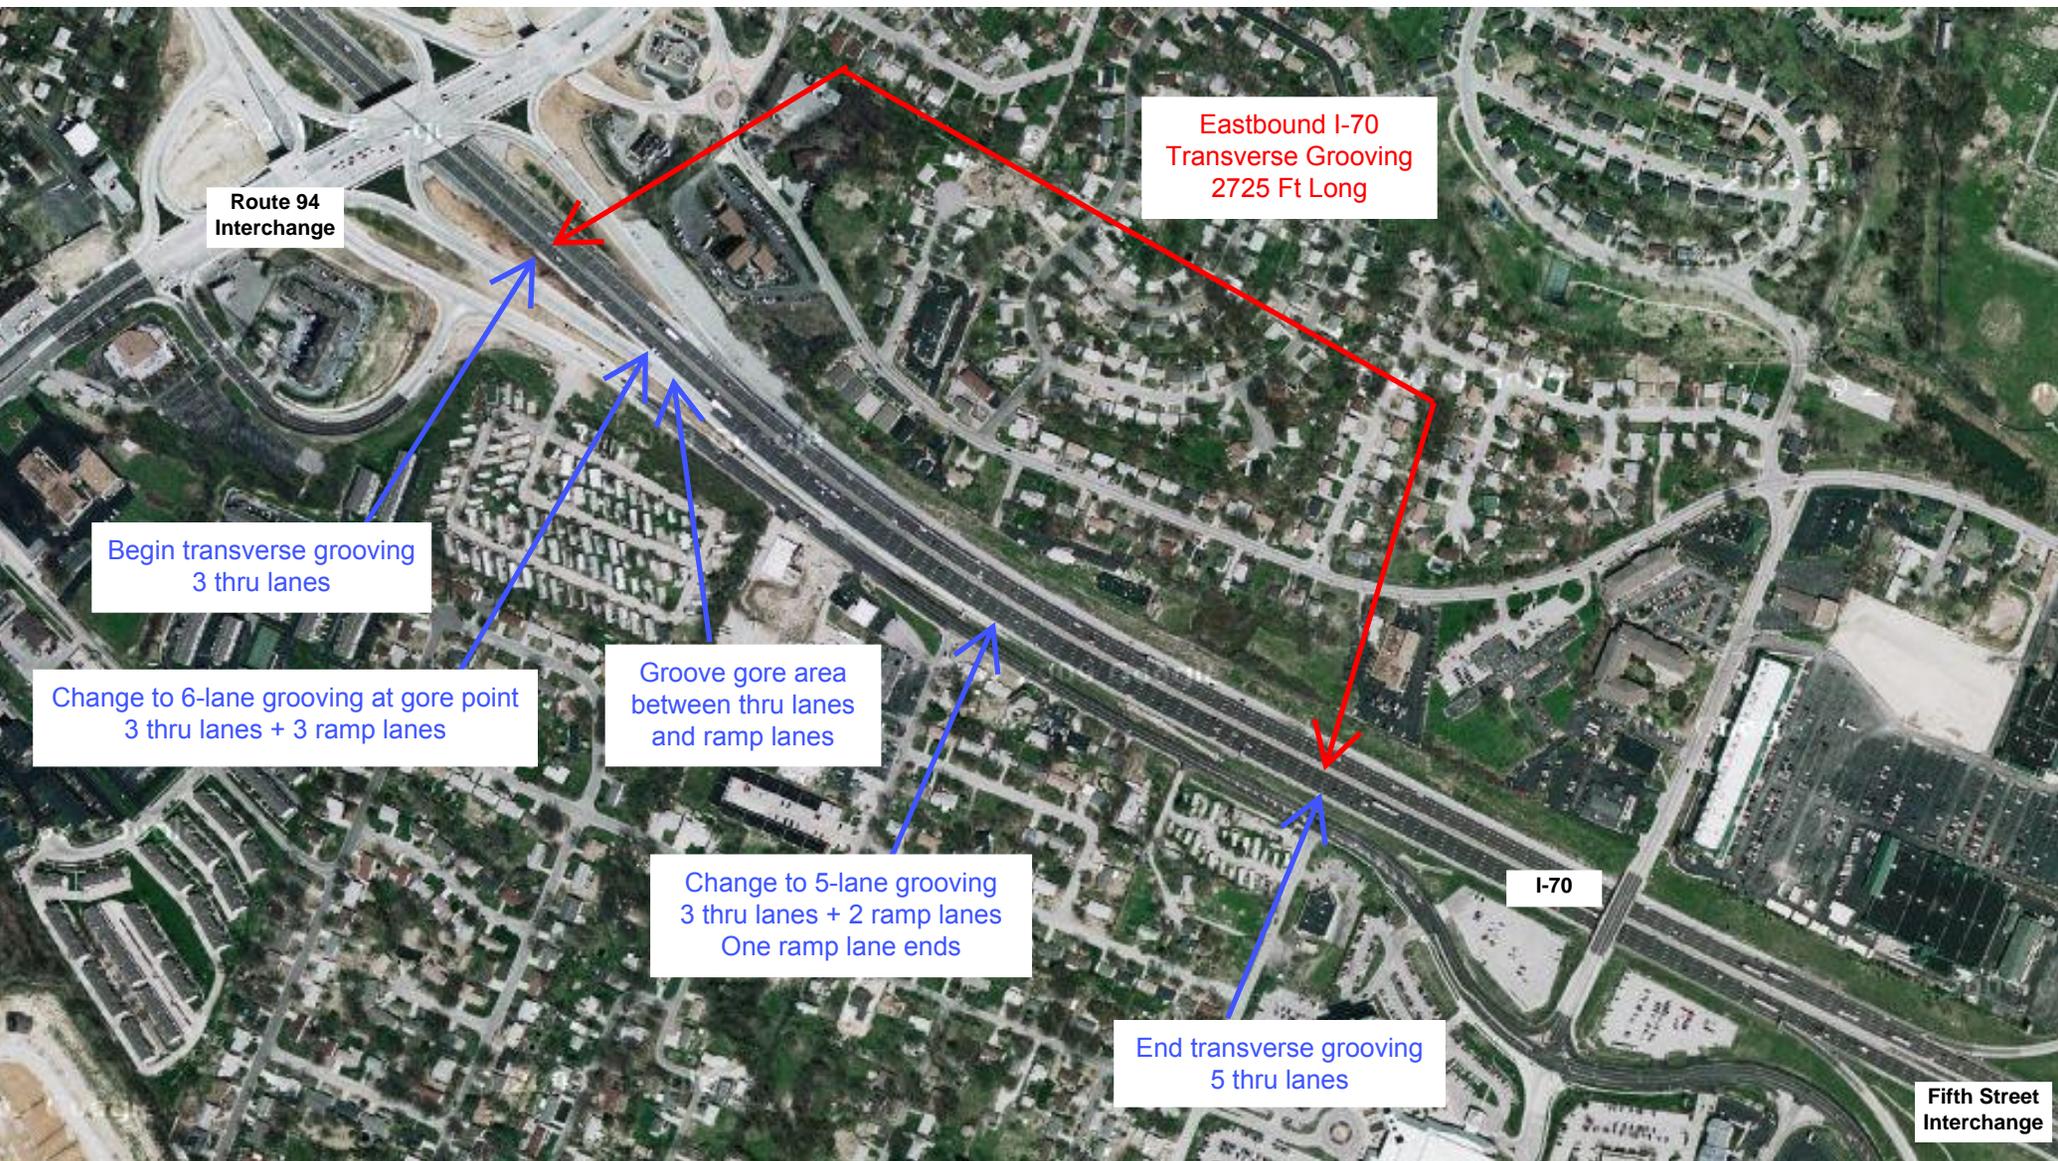
Begin transverse grooving  
3 thru lanes

Change to 6-lane grooving at gore point  
3 thru lanes + 3 ramp lanes

Groove gore area  
between thru lanes  
and ramp lanes

Change to 5-lane grooving  
3 thru lanes + 2 ramp lanes  
One ramp lane ends

End transverse grooving  
5 thru lanes

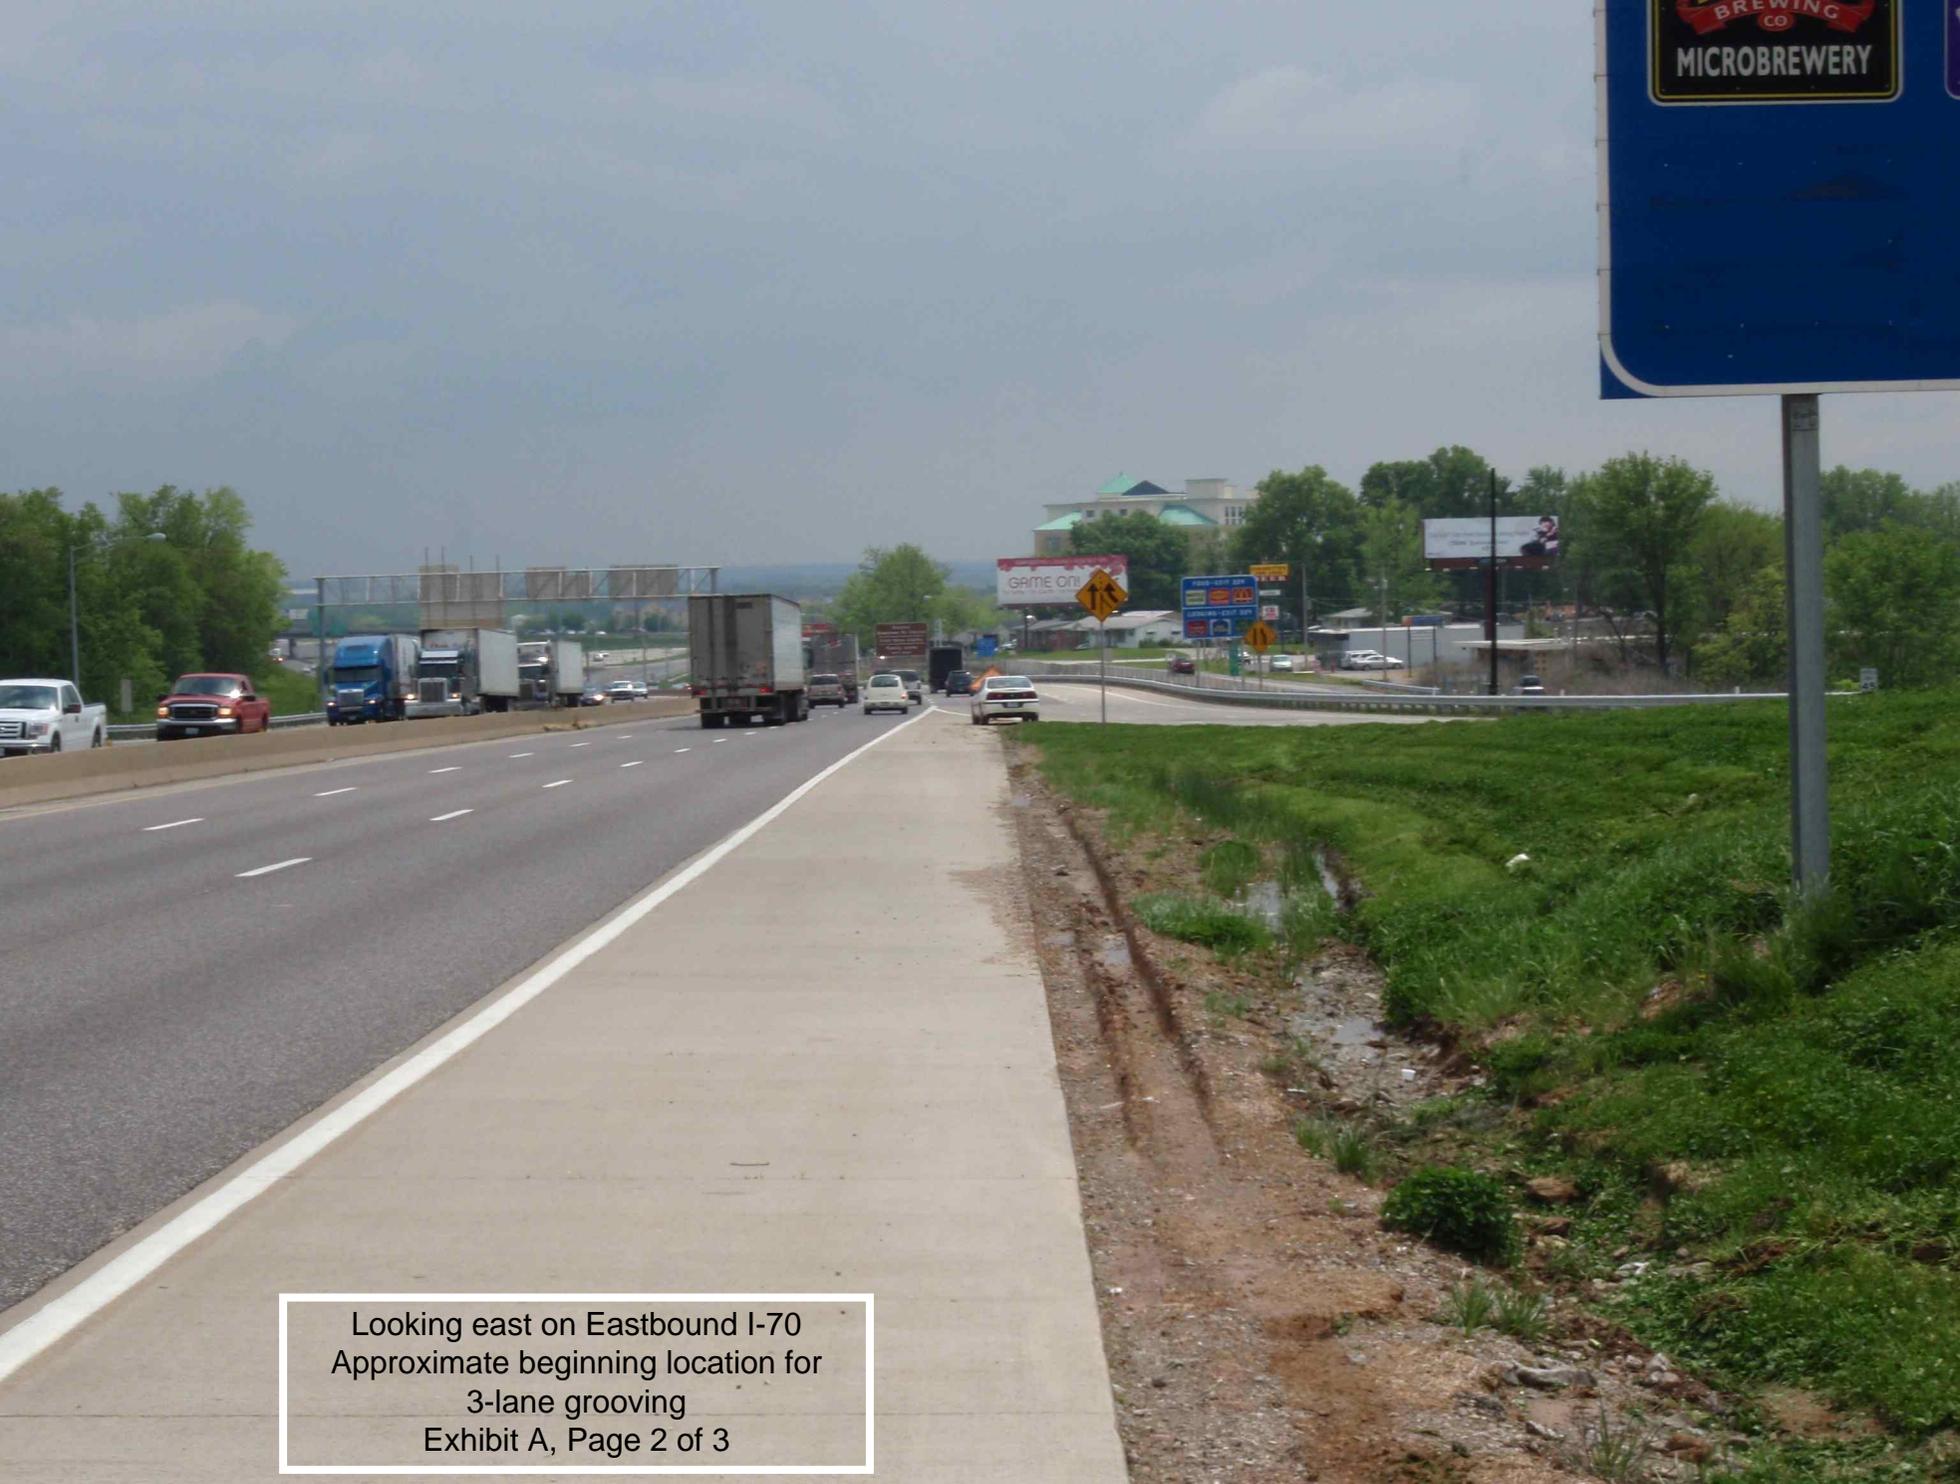
Looking east on Eastbound I-70  
Approximate beginning location for  
3-lane grooving  
Exhibit A, Page 2 of 3

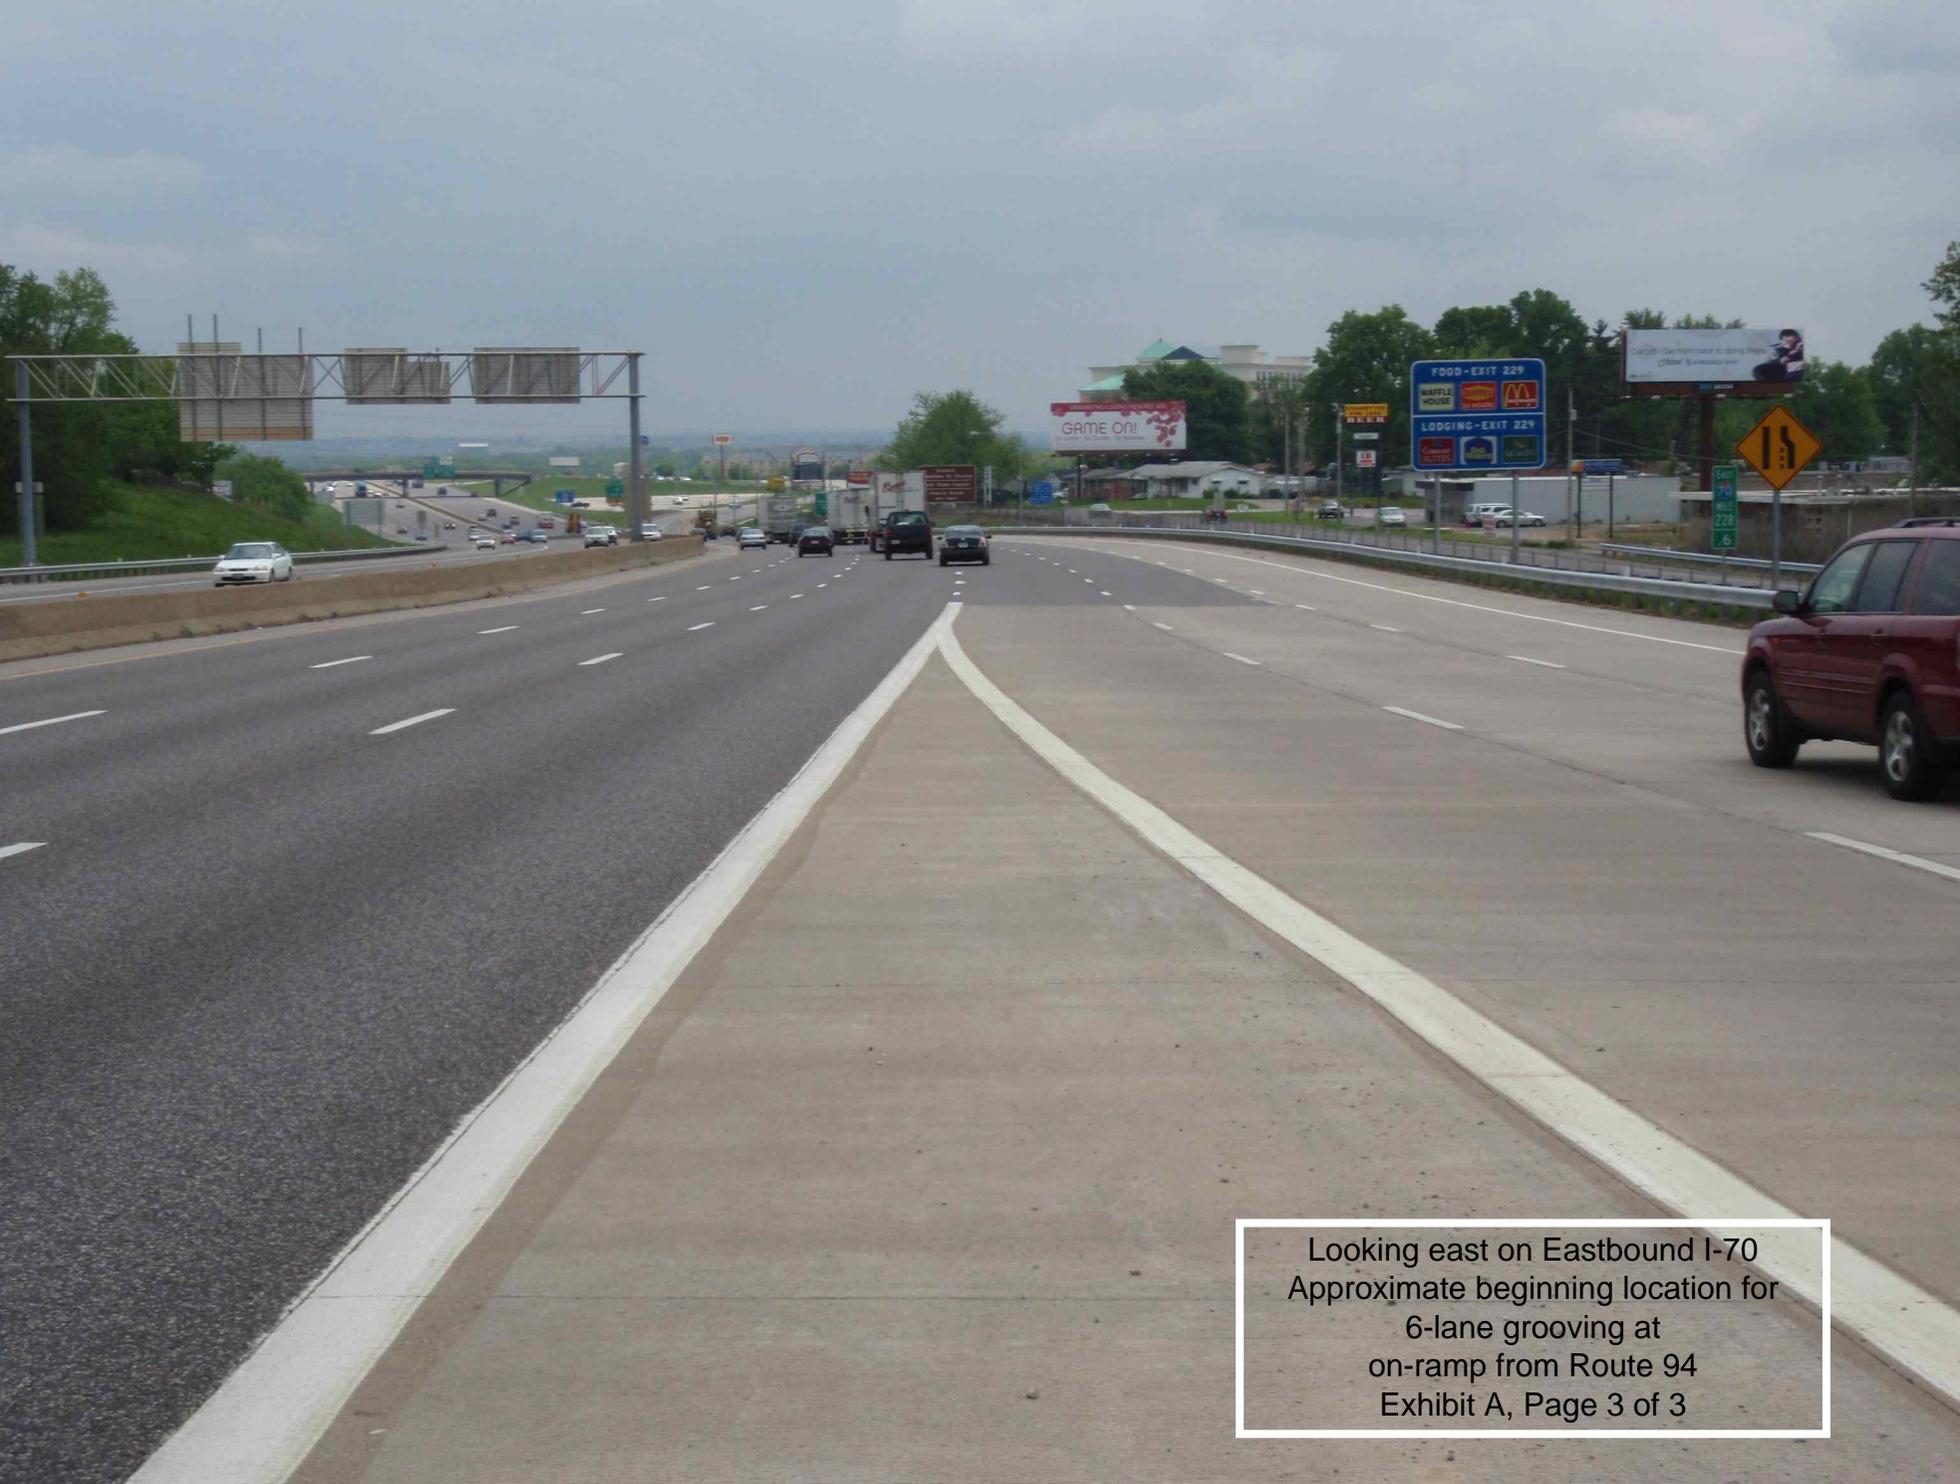
Looking east on Eastbound I-70  
Approximate beginning location for  
6-lane grooving at  
on-ramp from Route 94  
Exhibit A, Page 3 of 3
