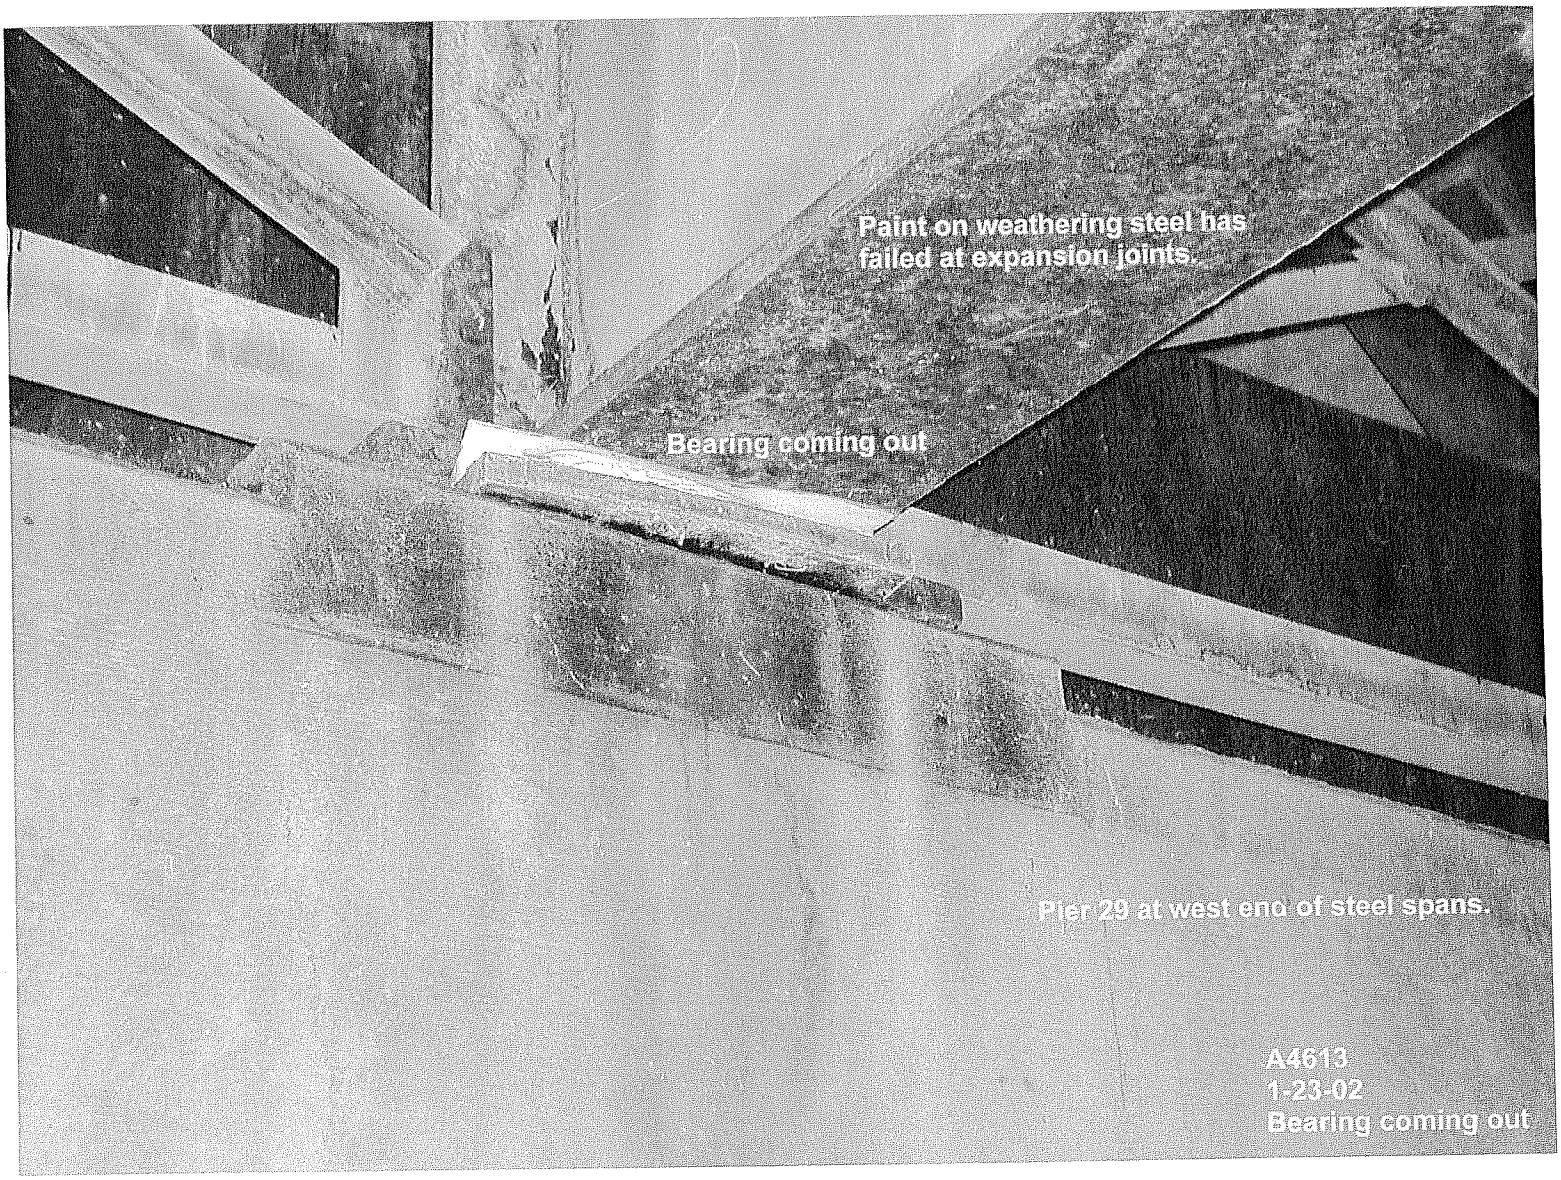
Paint on weathering steel has failed at expansion joints.
Bearing coming out
Pier 29 at west end of steel spans.
A4613
1-23-02
Bearing coming out

A4613 05-23-06
PIER 7 GDRS 3 & 7 NEOPRENE BRGS WORKING OUT.BE
